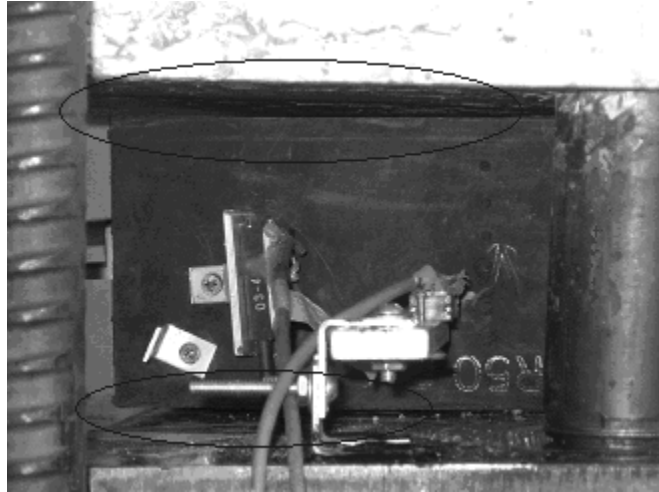
Figure 66. Visible gap between pile cap and bearing pad

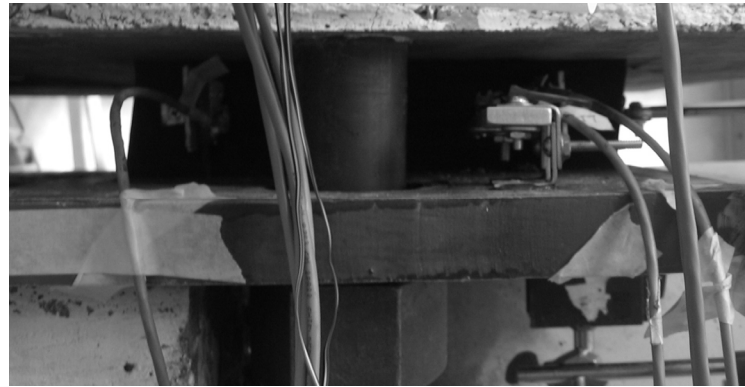
As the testing sequence progressed, the deformation of the bearing pad became more notable as the axial load and bearing pad load were increased for all three piles. Figure 67 shows the deformation of the Type VI bearing pad furthest away from the actuator during pushing the circular pile under the inelastic cycles.

Figure 67. Shear deformation of the type VI bearing pad
